HISTORIC AND ARCHITECTURAL PRESERVATION COMMISSION

THE FUTURE FOR OXFORD'S PAST:

**DESIGN GUIDELINES FOR
THE CITY OF OXFORD'S
HISTORIC DISTRICTS**

REVISED JULY 2011

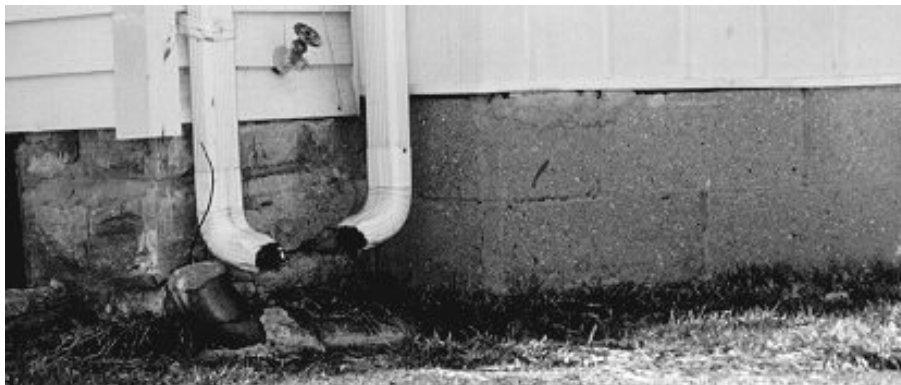
NO – Cinder block foundation (right) of new addition has not been treated to blend with the original stone foundation (left). Also, the downspouts discharge right next to the building.

1. New residential and commercial construction must not include exposed concrete block or cinder block foundations. If this material will be above grade (due to a sloped lot or other unavoidable geographic reason), historically appropriate facing treatment should be applied to the exposed portions of the foundations.

4. In order to protect against moisture damage to foundation walls, downspouts should drain away from a foundation.

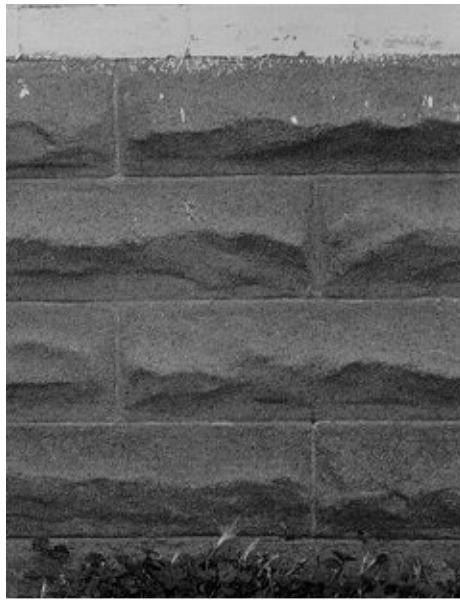
YES – A foundation which has been appropriately treated.

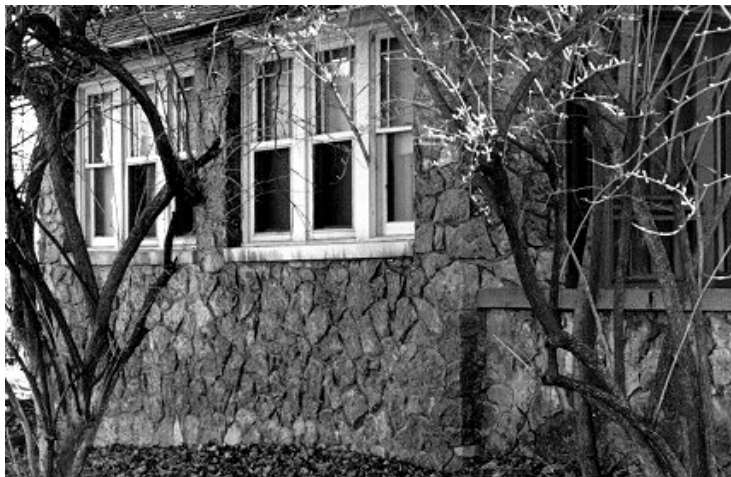
Good example of stone masonry.

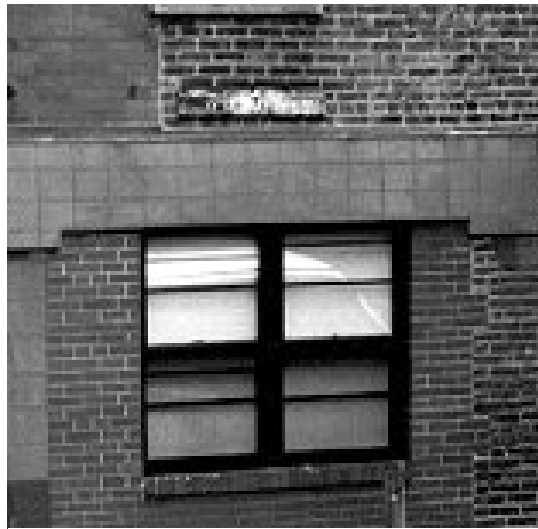
The various masonry additions to this building do not match in style, material, or

6. The masonry of any additions should resemble the existing structure utilizing like materials and style in order to be compatible with an otherwise historic building.

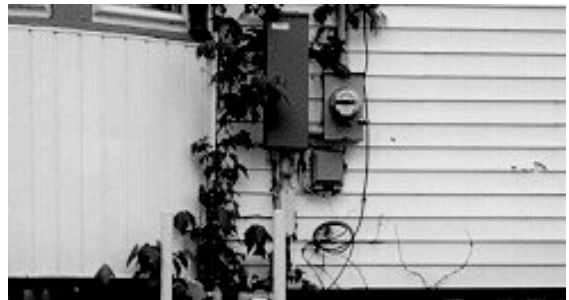
Not Like This – the bump-out window has been treated with artificial vertical siding that does not match the original horizontal wood siding to the left.

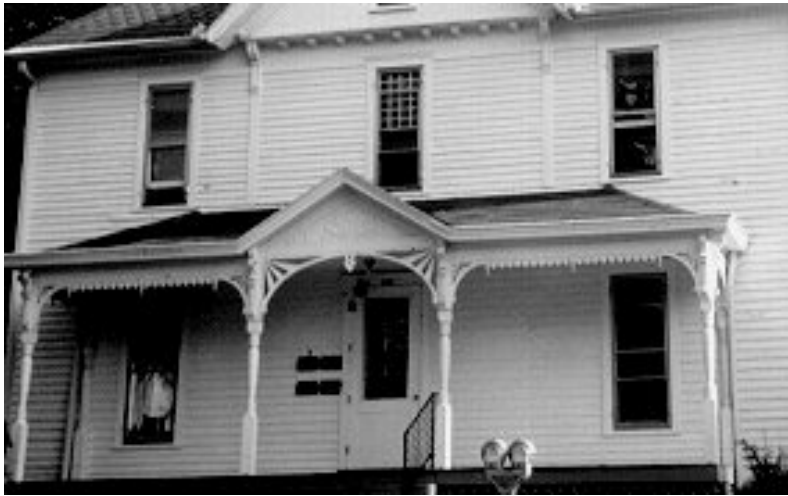
Good example of horizontal wood siding on a residential structure.

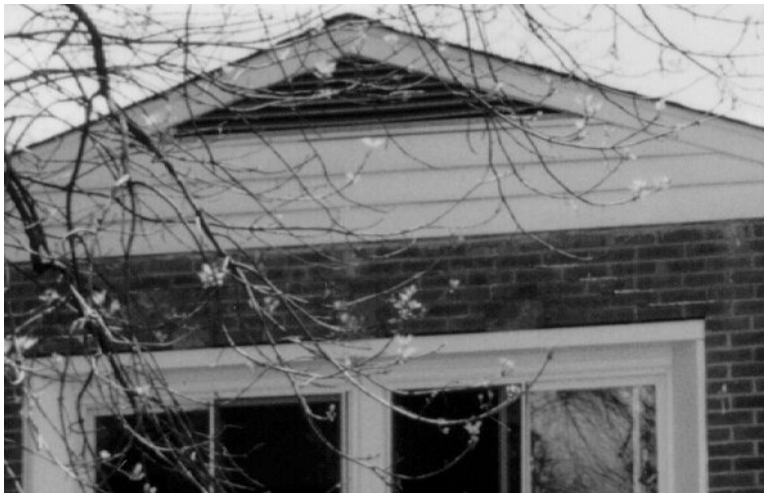
Siding such as this is inappropriate on commercial structures in the Uptown Historic District.

1. The use of siding, regardless of composition, is prohibited in new construction and renovations of commercial use structures in the Uptown Historic District.
2. No vertical siding will be incorporated into any structure within Oxford's Historic Districts. Plank treatments are to remain horizontal in fashion.
3. Decorative, wood shingles are an acceptable treatment for the residential structures in the Uptown District.

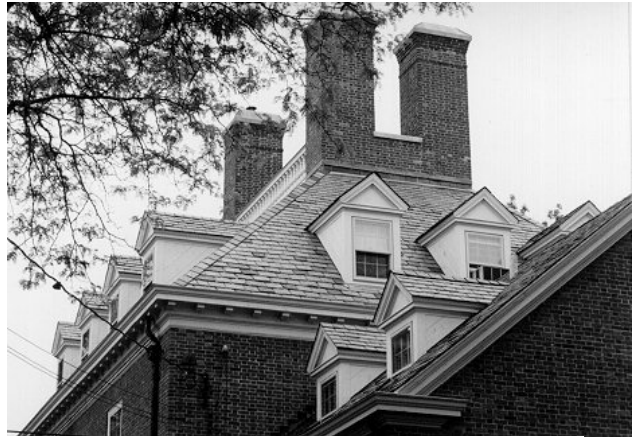
Extremely well maintained slate roof.

4. Care must be taken when making repairs to a slate roof as the shingles can crack and break relatively easily. Preservation and maintenance of slate roofs is greatly encouraged as there are very few remaining examples. Likewise, if properly maintained, slate roofs should provide last the lifetime of the building. Decorative patterns should be maintained and a professional roofer with experience dealing with slate roofs should be consulted.
5. Replacement asphalt shingles should match the color and shape of existing shingles.

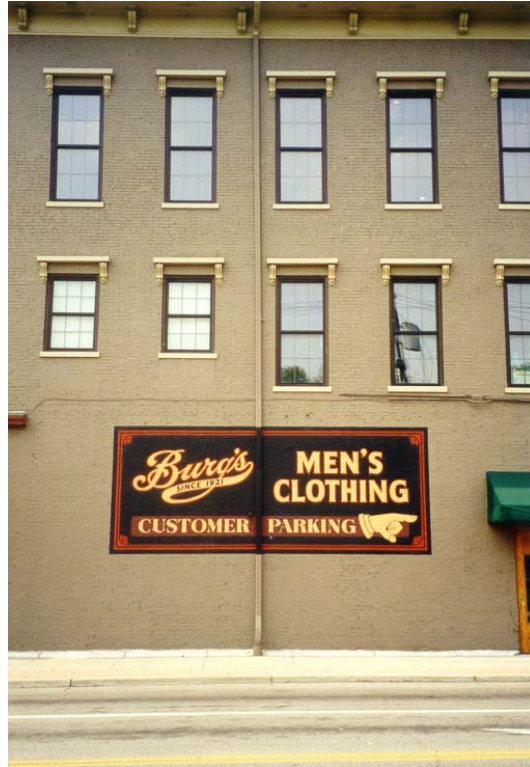
Although not located on a corner of the building, this gutter is sufficiently camouflaged by matching the painting scheme of the wall and trim.

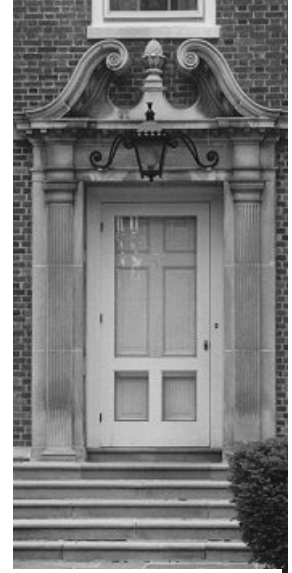
A good example of a sensitively designed storm door.

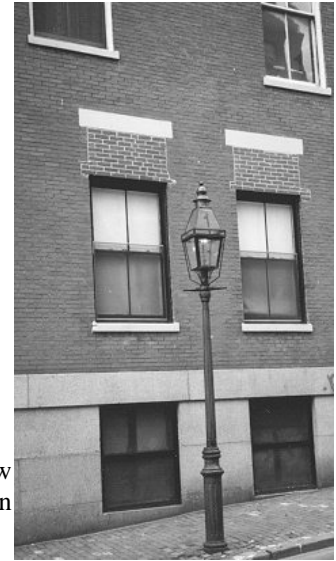
Insensitive window alteration has resized the window opening while leaving the original lintel and filling in the gap with a poor masonry treatment.

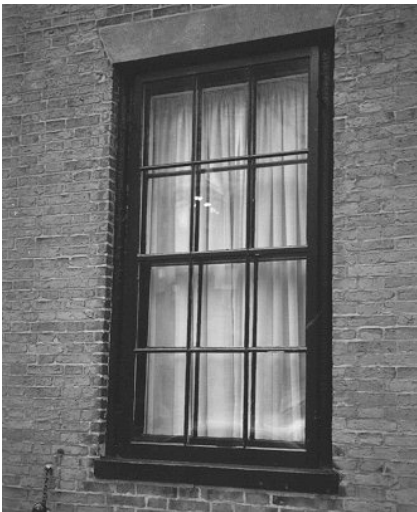
Good – Storm window exactly matches inner window.

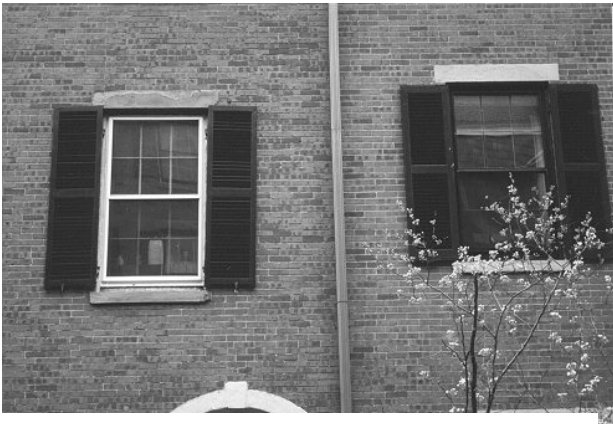
A coat of matching paint on a storm window and proper lintel maintenance can make the difference between a well maintained (right) and a poorly maintained (left) window opening.

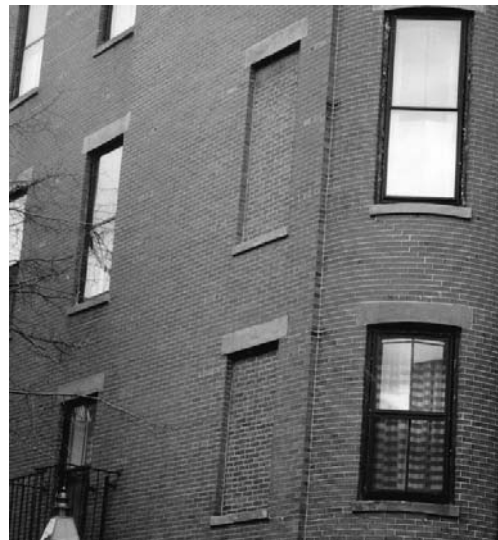
NO – In this example, the window openings have inappropriately been permanently filled with brick and the window glass removed.

10. Windows which are to be closed-off should not be removed and the hole filled in with some type of permanent material. Rather, the window should be maintained.

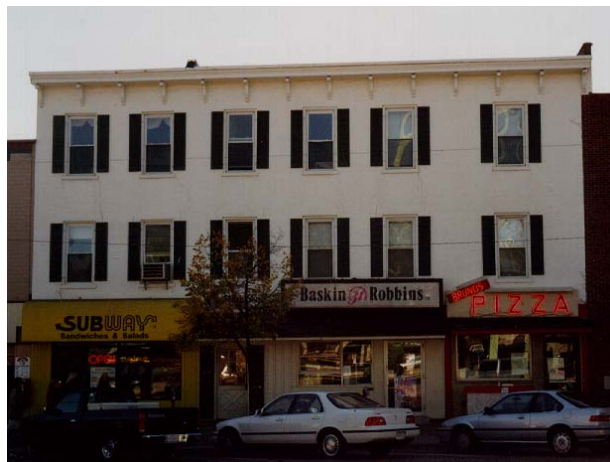
The upper façade is highlighted by rows of windows, not by differences in siding, arches, or columns.

1. New and restored structures should have perforations amounting to no less than 10% nor more than 40% of their upper story street facades.
2. Several other guidelines (cornices & friezes, siding, masonry, windows, ornamentation, etc.) should be utilized for work on upper facades.
3. The differences in floor levels should be highlighted through rows of windows or porch and roof treatments, but should not be emphasized with differences in siding, oddly shaped columns or arches, etc.

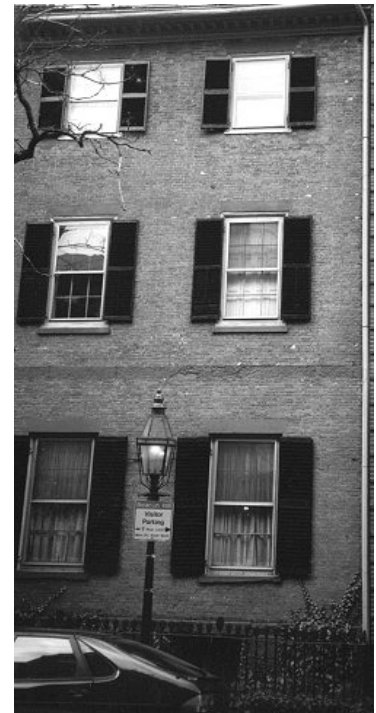
YES - All shutters are proportional to window openings.

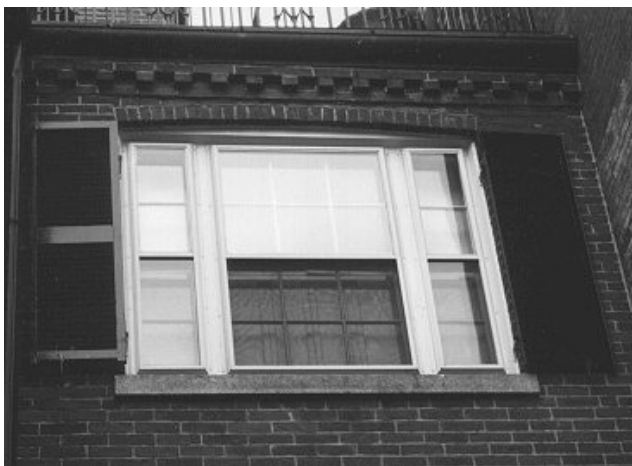
Clearly, these shutters could not cover the window opening and are thus inappropriate.

1. The use of wood for shutters is strongly encouraged, as this was the principal material originally used in their construction. Matching details such as louvers and bracing to any existing shutters is also important to maintaining the uniform look of a particular structure.
2. The use of metal, aluminum, and vinyl materials is discouraged.
3. Shutters do not have to be operable. However, when present they should appear to be functional and they should be proportionally equal to the adjacent window opening

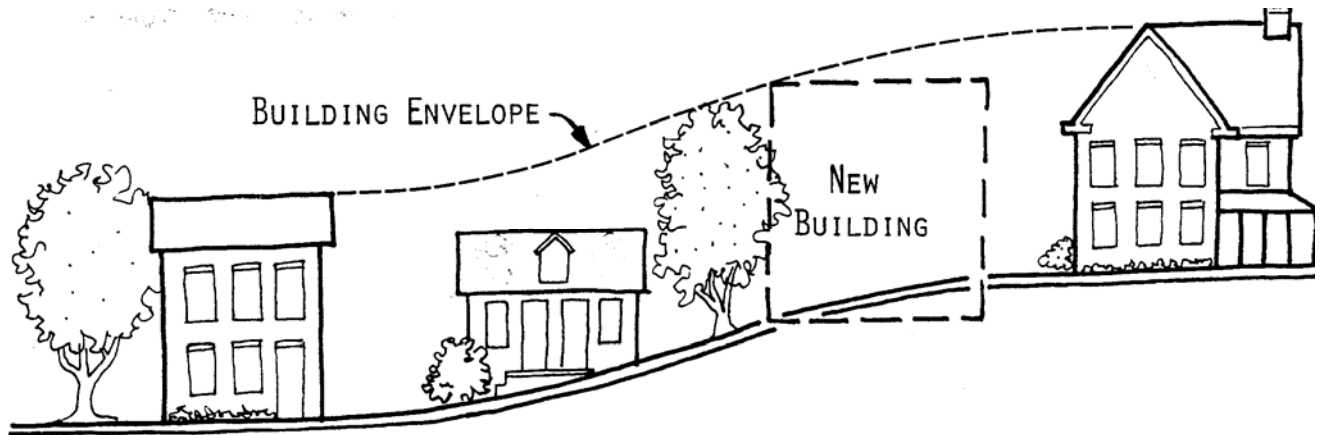
Example of a building envelope along a block.

1. For both commercial and residential structures, the height of a new building or addition should conform to the height of the existing building envelope along the adjacent block(s).
2. Buildings on corner lots should relate in setback and height to the structures along both adjacent blocks.
